MUDFLOW OF 1941 AT WRIGHTWOOD, SOUTHERN CALIFORNIA

BY ROBERT P. SHARP AND LAURENCE H. NOBLES

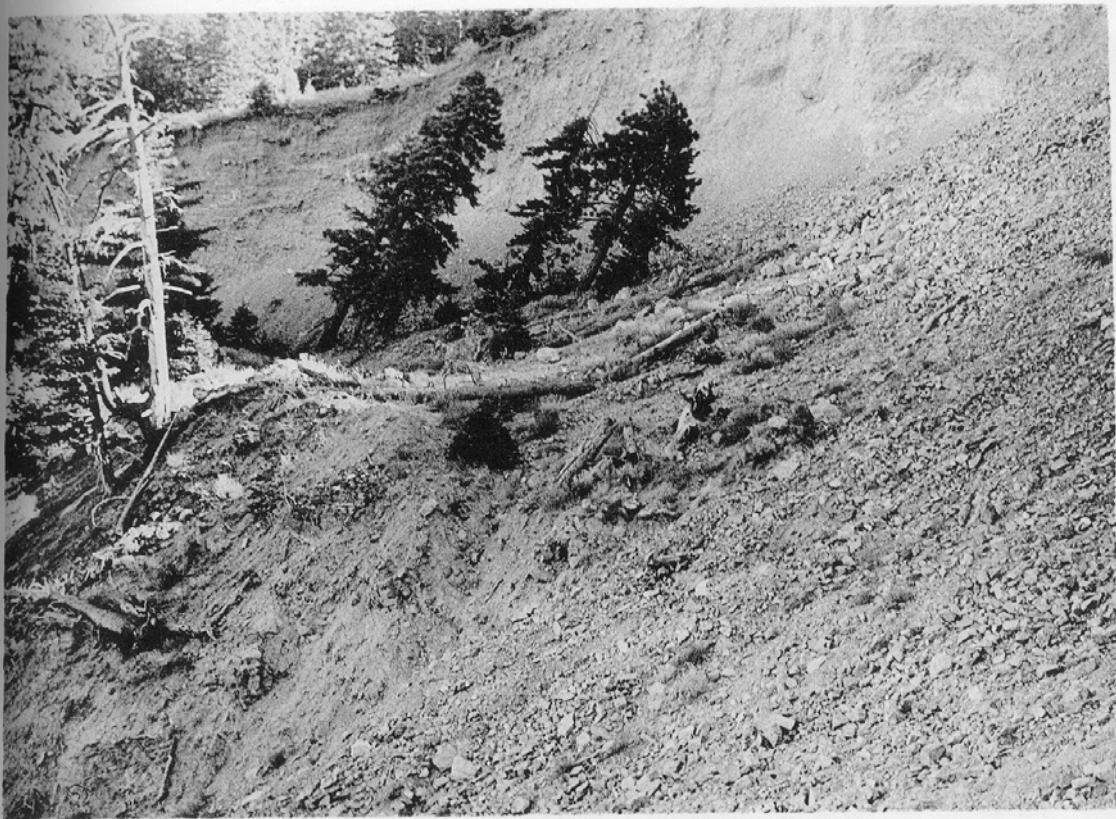
FIGURE 1

FIGURE 1.—TILTED SLUMP BLOCK

Near top and close to east margin of source area at head of Heath Canyon. High-level alluvium exposed in background. Nov. 15, 1948.

Small slump blocks, bearing large coniferous trees, dot the scar area, particularly the eastern part. Backward rotation of the blocks is recorded by tilting of the trees at angles up to 28° (Pl. 1, fig. 1). A few trees are tilted forward, presumably because their roots have been loosened so they naturally lean downhill.

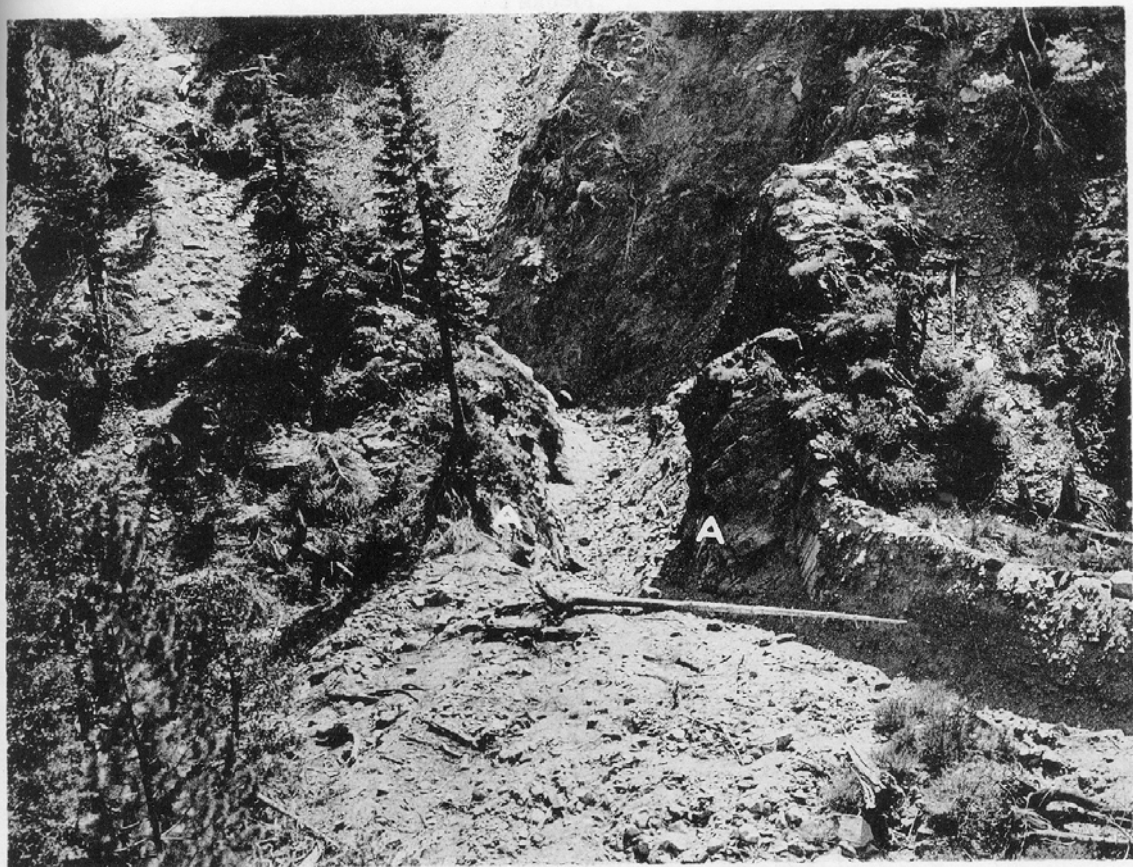
FIGURE 2

FIGURE 2.—DOWNSTREAM END OF BEDROCK NARROWS AT FOOT OF SOURCE AREA

Looking upstream. Material for the mudflow was funneled through this gorge. Letters AA mark mouth of gorge.

At the lower end of the scar is a bedrock narrows 200–300 feet long, 15–20 feet wide at the bottom, and 75 feet deep with extremely steep walls (Pl. 1, fig. 2). All debris from the scar passes through this gorge which functions as a bottleneck. Remnants of debris fills, up to 75 feet thick, upstream from the narrows suggest that material gradually accumulates behind the bottleneck until an exceptional supply of water makes the detritus mobile. V. S. Aronovic's films and observations show that the narrows were periodically choked with coarse detritus during the 1941 flow and that subsequent collapse of the jam under increasing pressure of material accumulating upstream gave rise to a surge of debris travelling rapidly downstream.

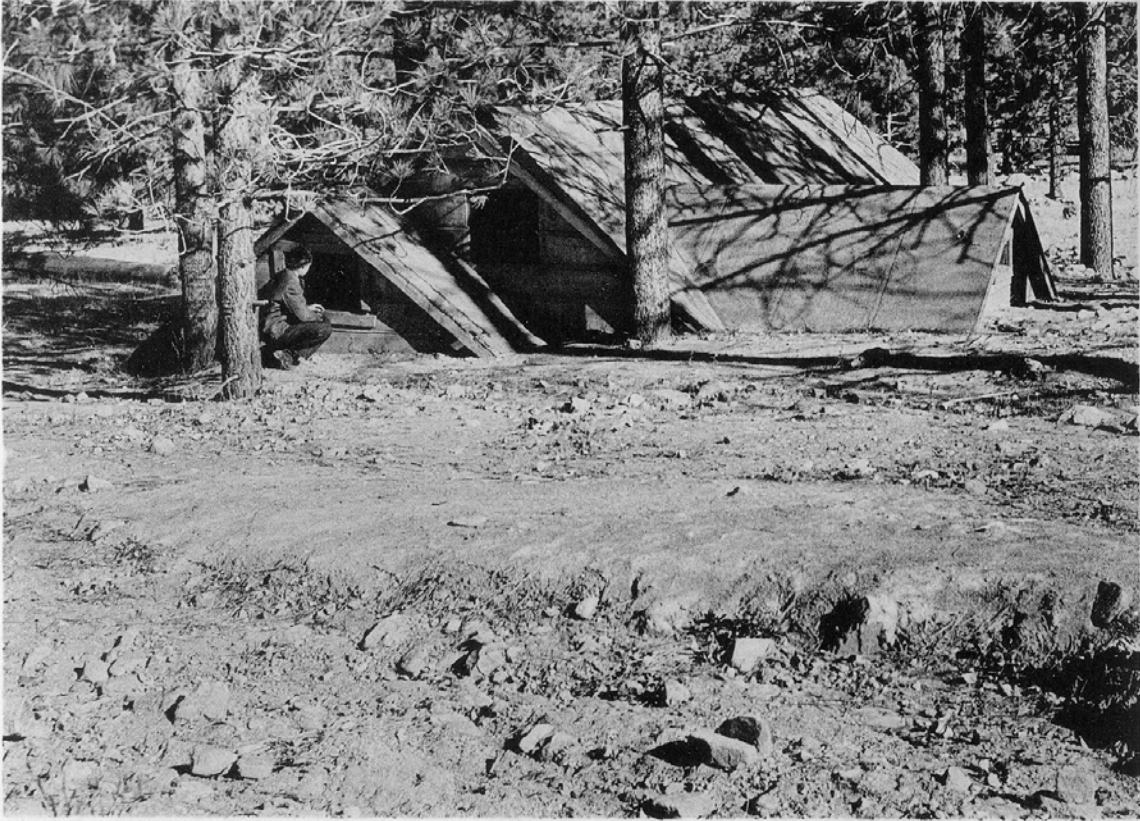
FIGURE 2

FIGURE 2.—CABIN OF SIDNEY YOAKUM AT WRIGHTWOOD

Filled and buried to the eaves by 1941 mudflow.

repair. A cabin and shed, owned by Sidney Yoakum, about 50 yards below the Lone Pine Canyon road were buried to the eaves by debris (Pl. 2, fig. 2). Curiously, neither building

appears to have been moved nor to have suffered damage other than burial and filling, probably because of low impact velocity and homogeneous flow. Similar occurrences elsewhere are reported (Troxell and Peterson, 1937, p. 87). The walls of other buildings at Wrightwood were said to be partly caved in. Warnings were ample so that no one was trapped, and most furniture was removed from the cabins. A small fruit orchard at Wrightwood was ruined by the flow, many trees being broken down or killed by partial burial. Roads were buried, but paving for the most part was not seriously damaged, a performance rather typical of mudflows (Blackwelder, 1928, p. 468). Courtesy WrightwoodCalif.com
