LANDSLIDING AND MUDFLOWS AT WRIGHTWOOD, SAN BERNARDINO COUNTY, CALIFORNIA

CALIFORNIA DIVISION OF MINES AND GEOLOGY

SPECIAL REPORT 136

PART I: WRIGHT MOUNTAIN LANDSLIDE: RENEWED MOVEMENT IN 1967

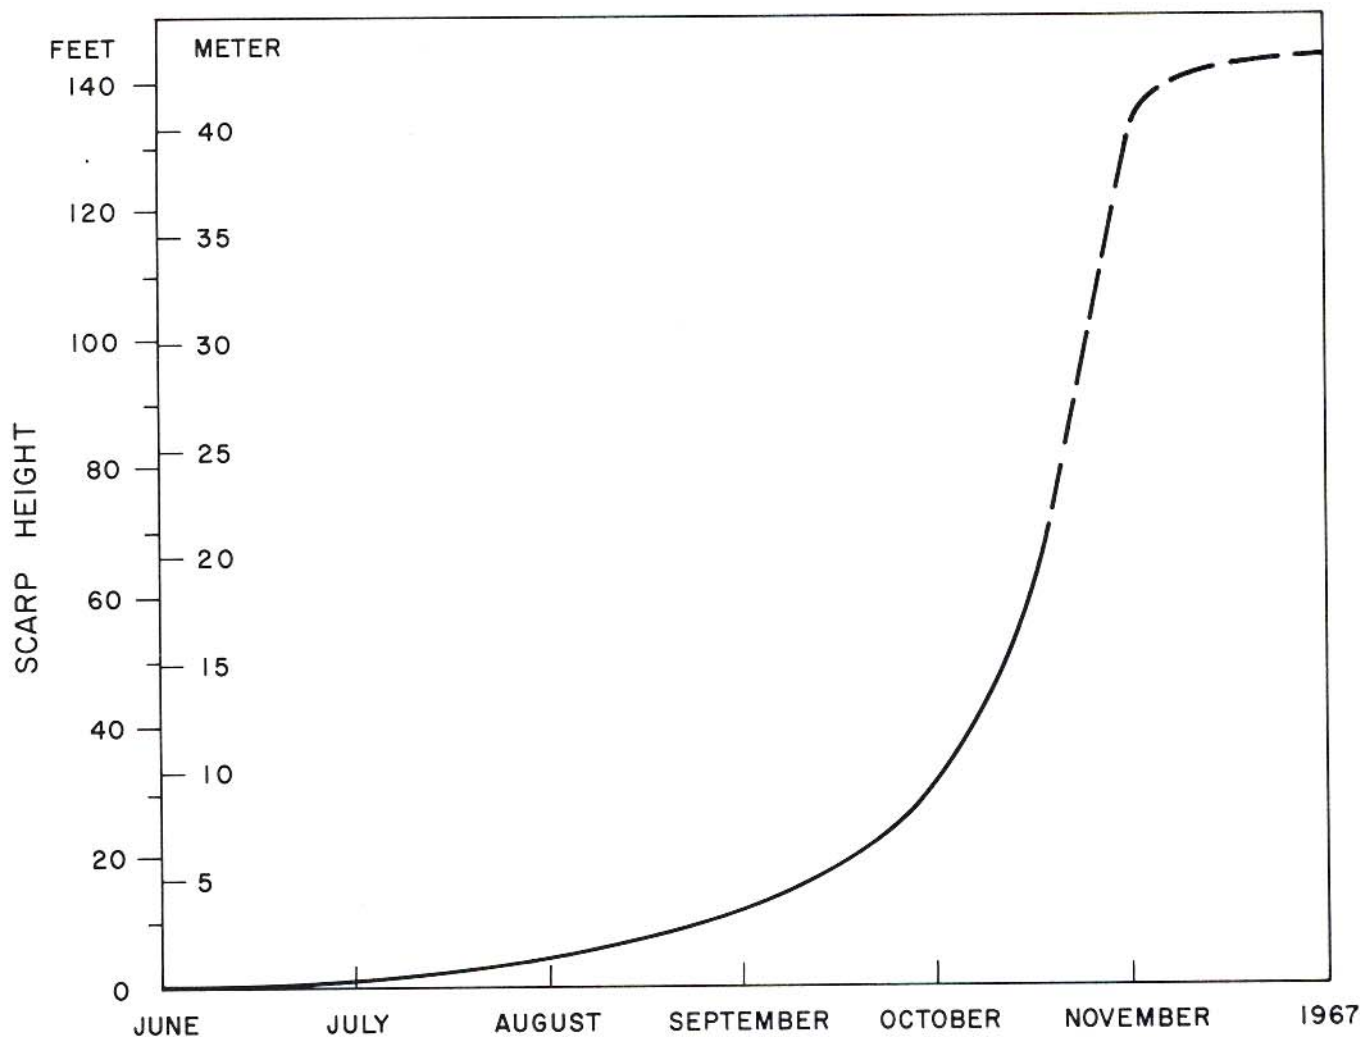
Figure 3. Diagrammatic representation of the rate of landslide movement between June and December 1967 as expressed by increase in scarp height.

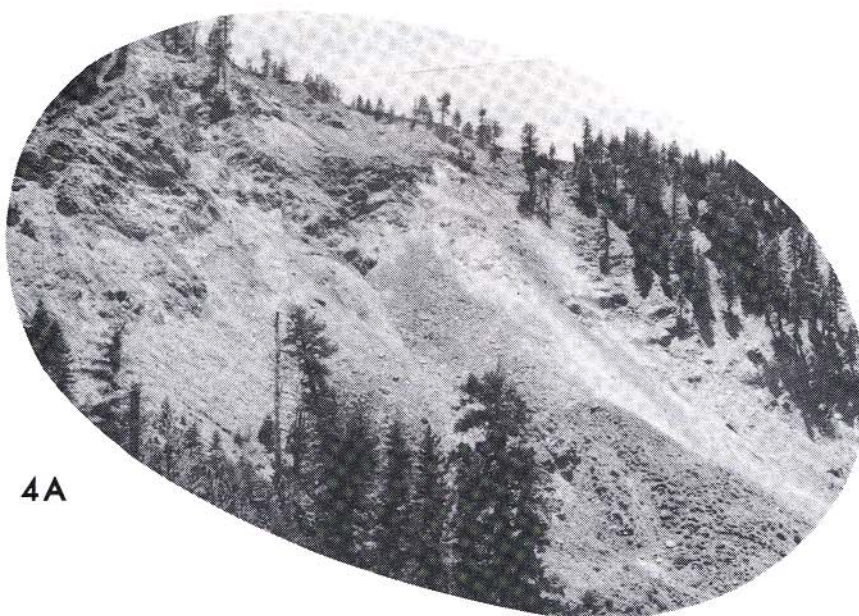
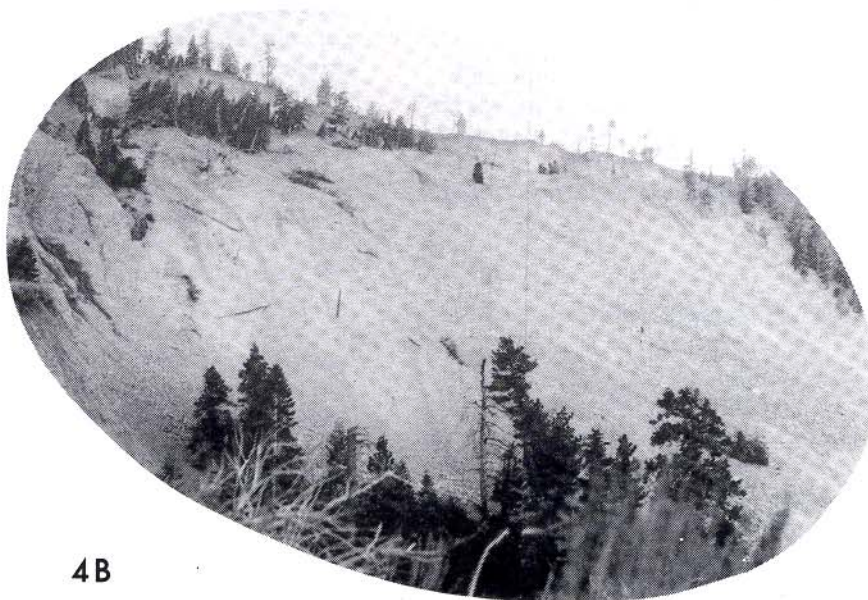
Figure 4. View looking southwest across the head of Heath Creek Canyon. Figure 4A was taken in June 1967, prior to failure of the active block. Figure 4B was taken in November 1967, after failure of the active block.

The surface in the center of the block (general area of building on figure 4) remained horizontal throughout the movement. Backward rotational movement, however, was pronounced during the later part of the period of landsliding, especially in the western and eastern parts of the block. The dip of the scarp was 65° to 75° north. Slickensides in the center of the scarp were directly down dip. On the western side, the slickensides had a trend 10° to 15° west of the dip, and on

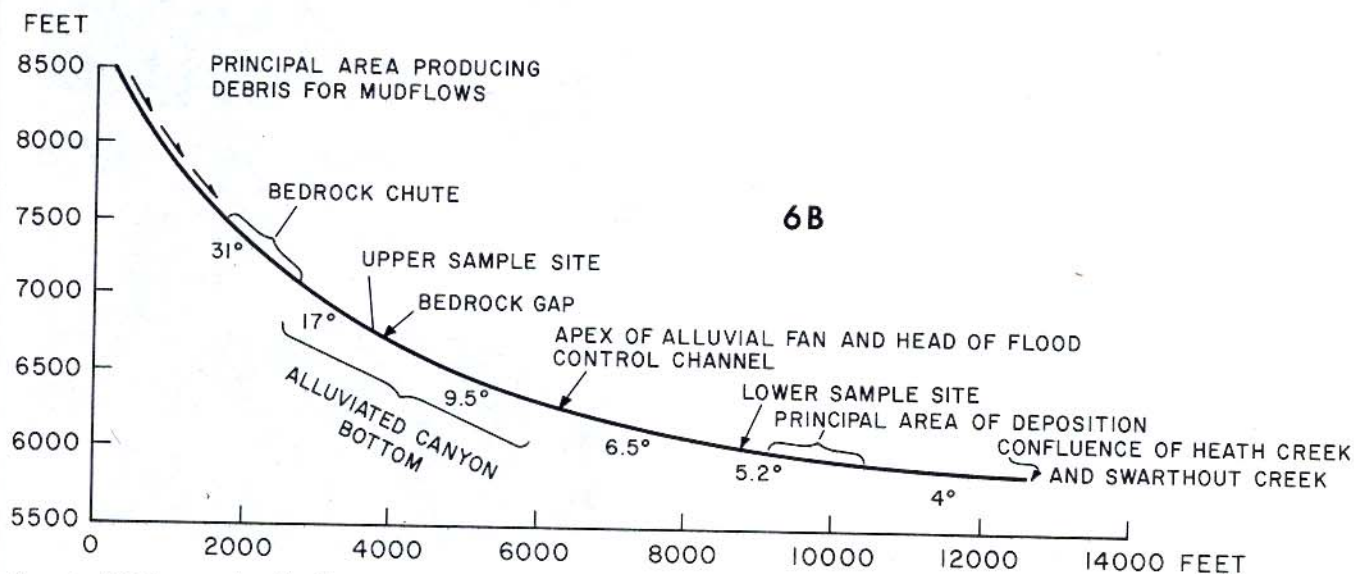
Figure 6. Sketch map and profile of the Wright Mountain landslide. Figure 6A outlines Wrightwood and the Wright Mountain landslide, and shows the mudflow course, with gradients, along with the principal source area of debris for the 1969 mudflows. Figure 6B profiles the Wright Mountain landslide, showing mudflow gradients and sample sites.

The upper of two sample sites (figure 6) was about 200 feet upstream from the "narrows" in the alluviated canyon reach. The lower sample site was about 200 feet upstream from the conjunction of the controlled channel with the controlled depositional reach.

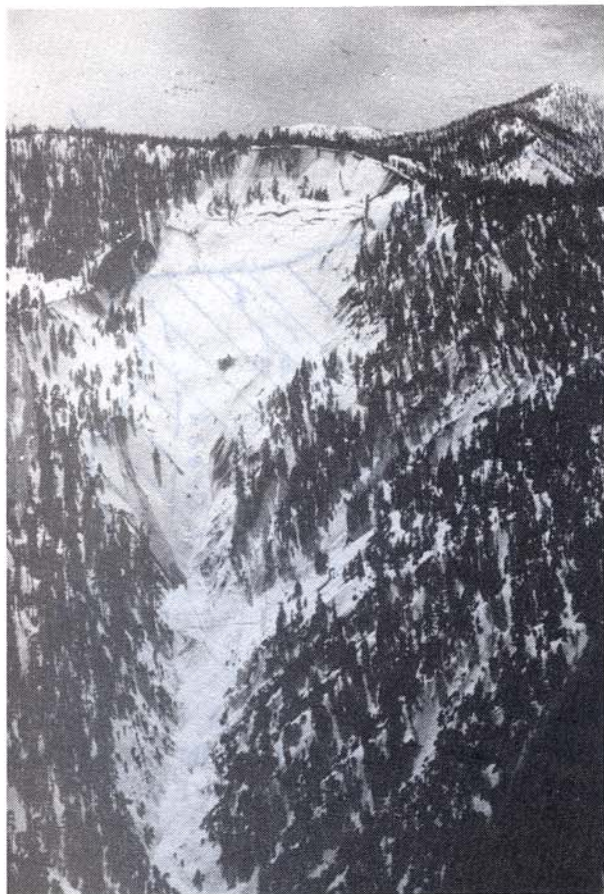
Figure 7. Wright Mountain Landslide, March 1969.

A deep snowpack developed during the winter of 1968-69. Snow depth on Wright Mountain, measured on March 3, 1969 (figure 7), ranged between 68 and 104 inches with an equivalent water content of 26 to 45 inches (J.R. Townsend, personal communication, 1969). Thus, early in the spring of 1969 upper Heath Canyon contained abundant debris and an adequate source of water for spring mudflows.

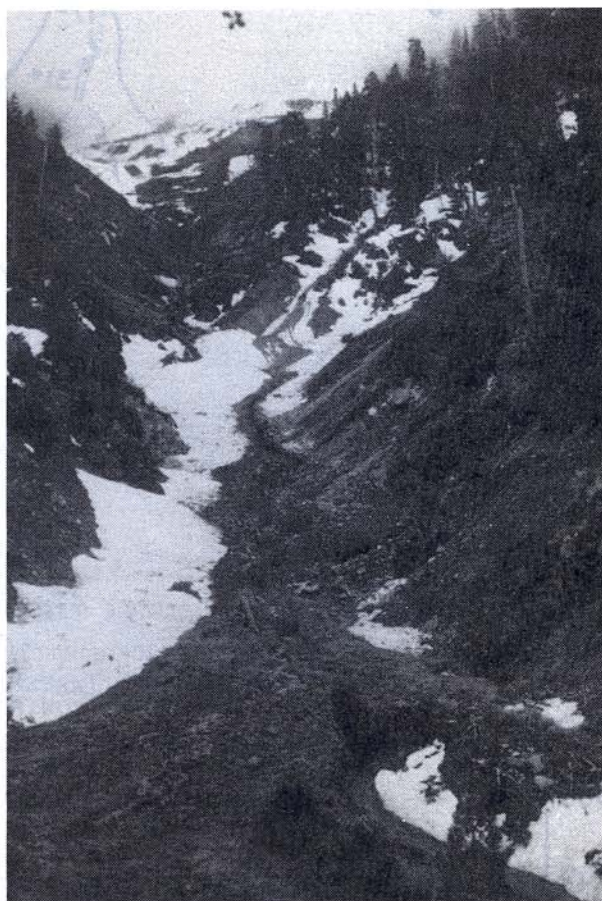
Figure 8. View up alluviated canyon bottom (17th reach) during the waxing stage. Debris for mudflows at this time (May 5, 1969) is in the area immediately below the narrow U-shaped channel.

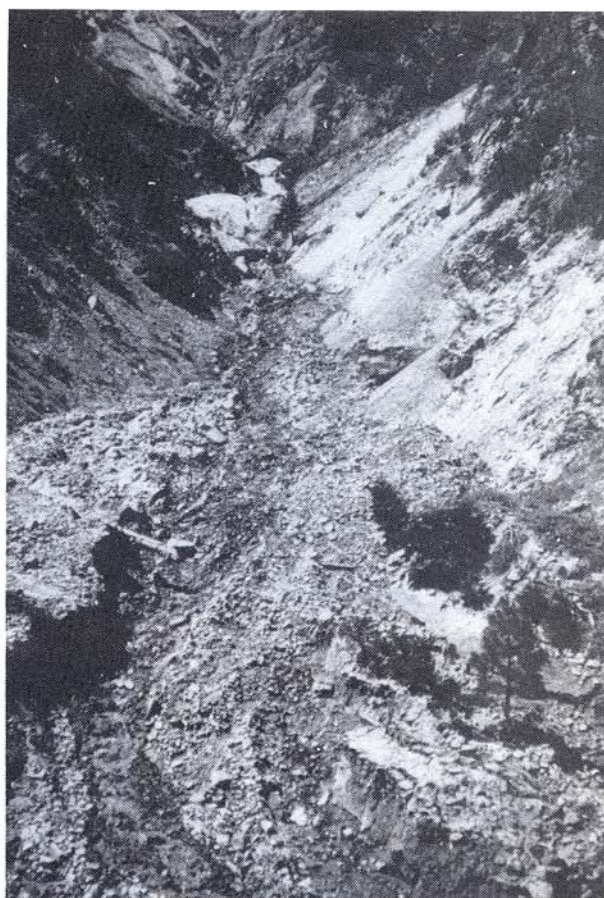
Figure 10. Same view as figure 8, taken during the waning stage of the mudflow cycle after most of the deep channel had been filled.

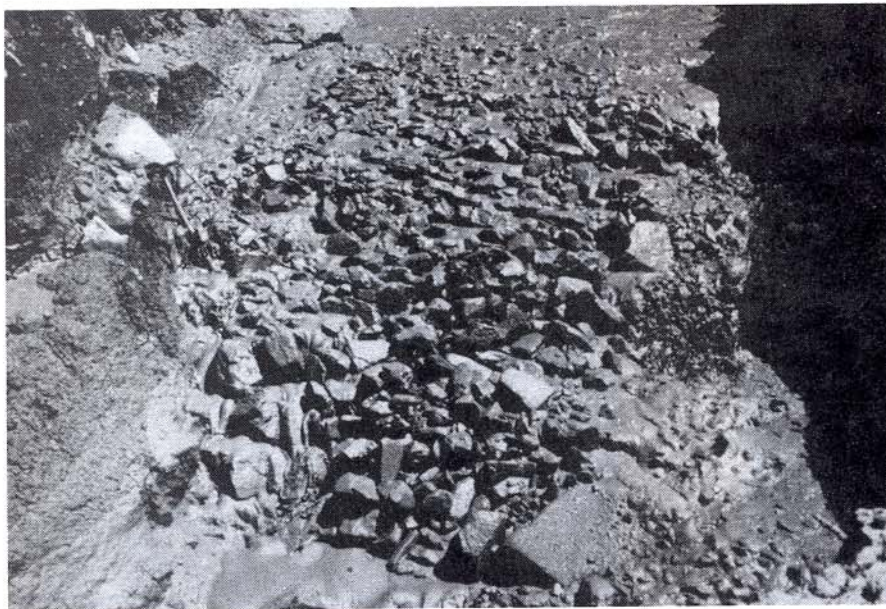
Figure 11. Near vertical angle view of rock front of mudflow immediately above bedrock gap. Note the well-sorted nature of the rocks (larger ones two feet in diameter) constituting the front, and also the apparent decrease in clast size and the progressive increase in mud content behind the front.

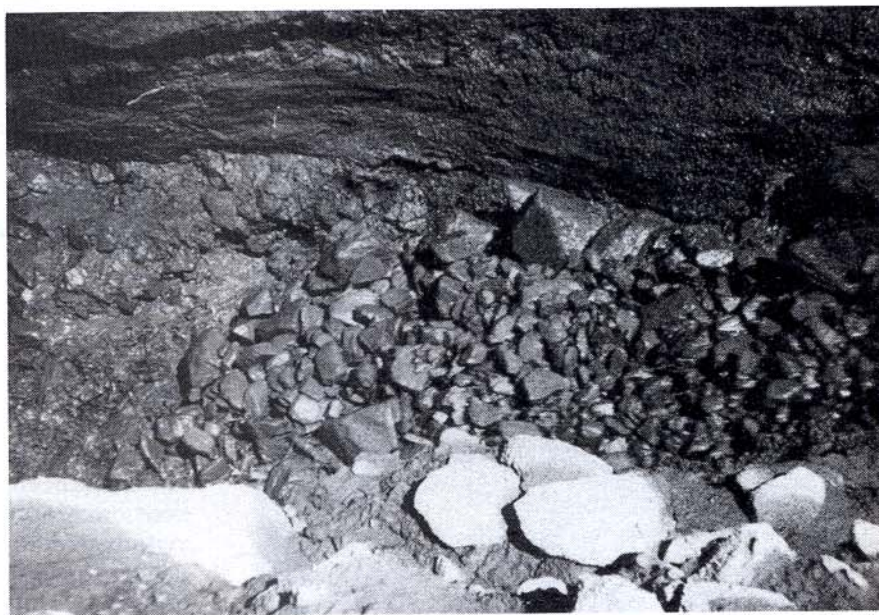
Figure 12. Vertical view of long rock front of mudflow in the area shown in figure 11. The width of the flow is approximately eight feet. The smooth channel sides are buried snow.

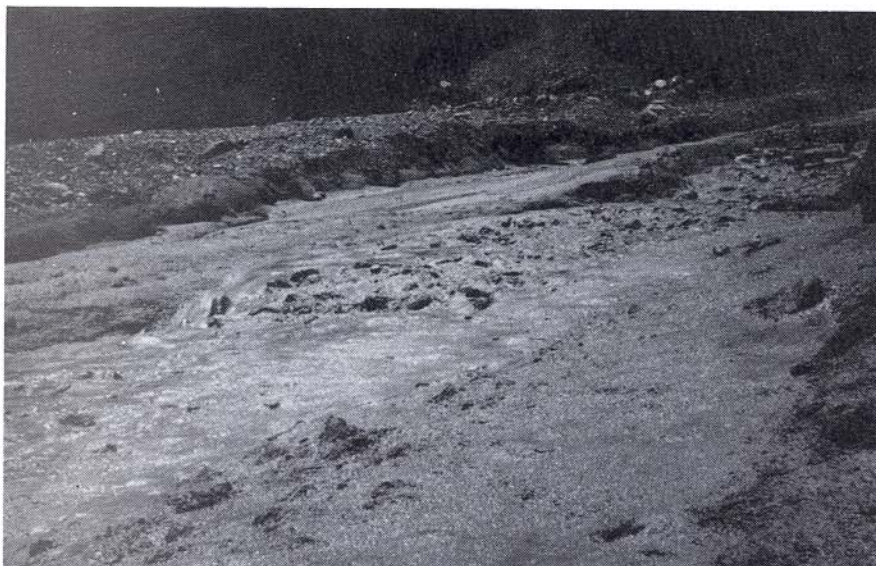
Figure 15. View of the mudflow immediately above area of principal deposition. Note the low front and its mixture of rocks and mud. The width of flow is approximately 12 feet.

During the climactic stage, mudflows reached the gentler gradient of Heath Canyon fan and moved across its upper part where individual masses tended to merge, forming larger, more continuous flows in which the rocky snouts of former individual mudflows were recognizable only by short flow segments containing concentrations of boulders. The segments between boulder accumulations appeared visibly bimodal, with boulders interspersed in sandy mud (figure 15, 16, 17).

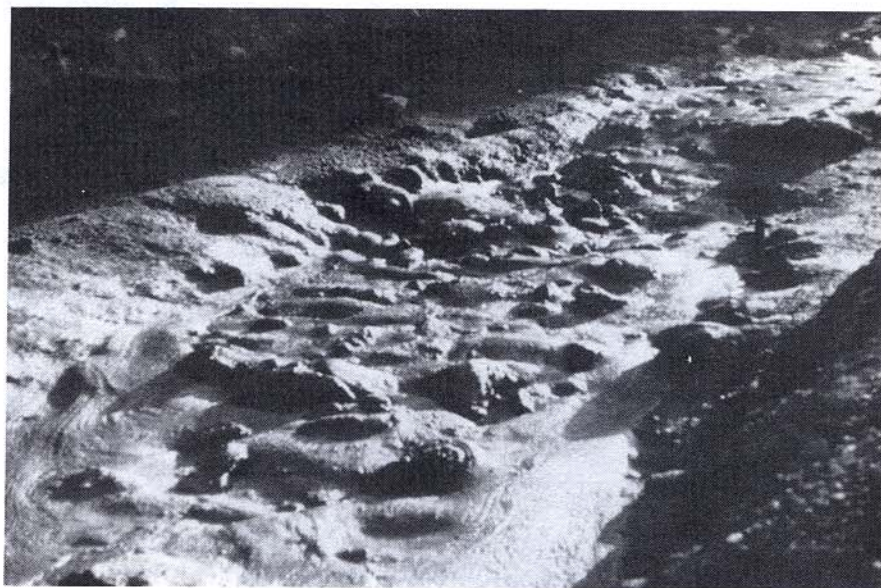
Figure 16. View of the mudflow above the area of deposition. Here the width of flow is about eight feet.

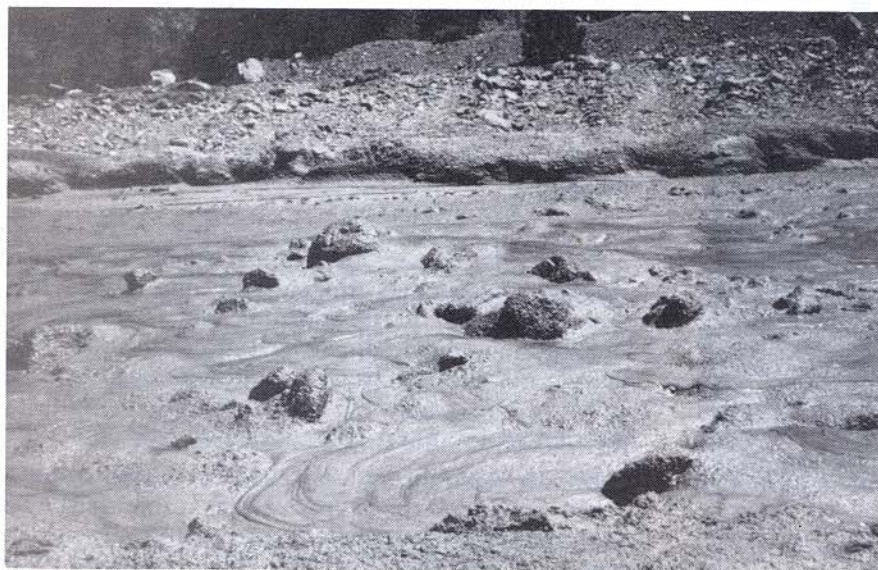
Figure 17. View of the mudflow in the area of deposition. Here the width is approximately 50 feet.

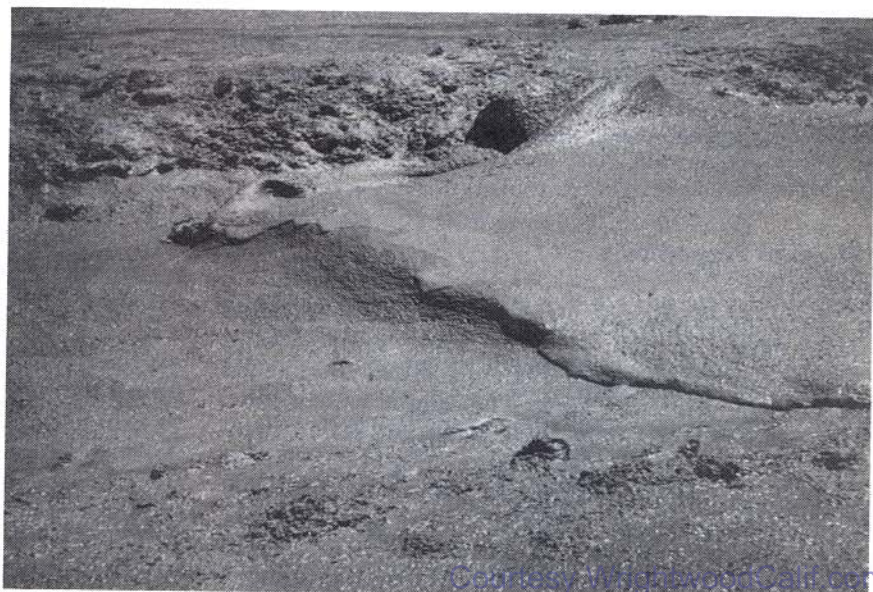
Figure 18. Translatory wave in gravelly sand, view at the lower sample site.

In the flood control channel of the alluvial fan, translatory waves 1 to several inches in amplitude were generated during the climactic stage (figure 18). These waves moved down channel at approximately twice the speed of advancing mudflows. Most waves
